HUGHES TOOL COMPANY · AIRCRAFT DIVISION  
Culver City, California

Report 285-18 (62-18)

HOT CYCLE ROTOR SYSTEM  
MATERIALS & PROCESSES

March 1962

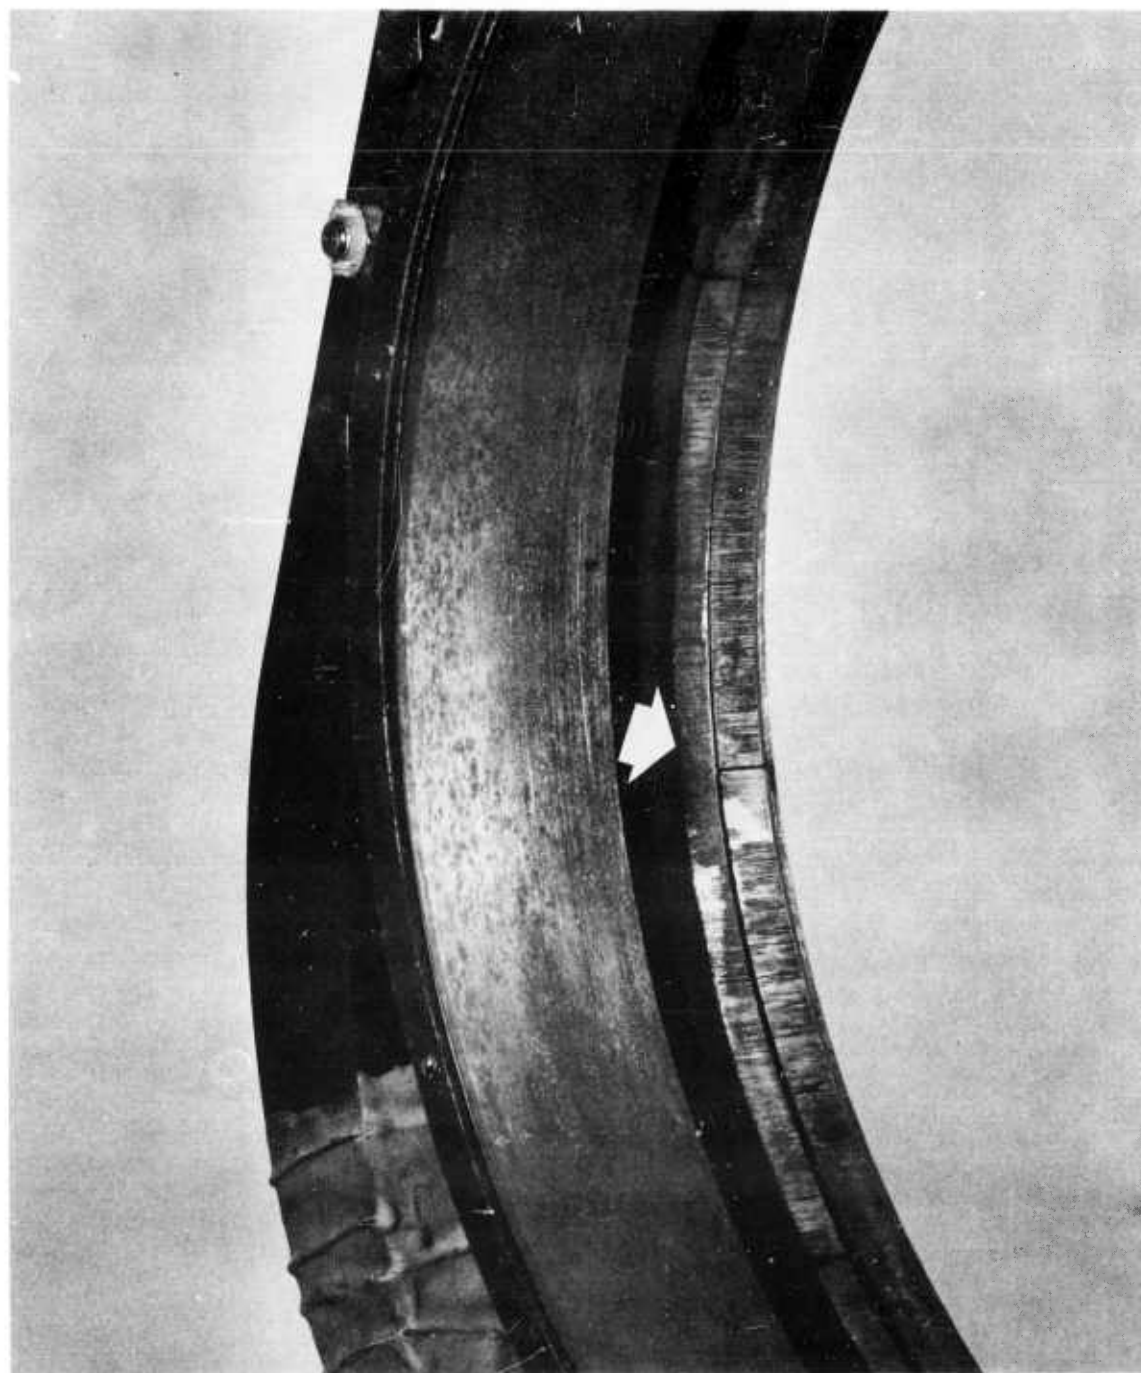
After 18 hours of whirl tests, inspection of the carbon seal materials disclosed some local soft spots in the U. S. Graphite No. 2490 and in the National Carbon Company's No. CDJ-83, which resulted in a tendency toward erosion. The softening and edge erosion can be seen in Figure 2.2-1. In contrast to the above, the Pure Carbon Company's No. 56 HT showed no evidence of softening in any portion of the material.

**Figure 2.2-1** Close-up of Articulate Duct Inboard Seal Segmented Carbon Rings.  
Note local softening of carbon and resulting erosion of edge.

The 56 HT segments, because of damage in service or handling, were replaced. The #2490 face seal ring, because of leakage through the soft eroded area, was reground flat and smooth and reinstalled. However, since the CDJ-83 seals showed no signs of appreciable leakage, these particular segments were again utilized for an additional 17 hours of whirl tests. At the end of that time, inspection revealed the following:

- a. The 56 HT segments were in excellent condition and were re-installed.
- b. The #2490 ring was again eroded to form a leak path, and because of diminished thickness, was replaced.
- c. The CDJ-83 segments appeared essentially as before and since leakage rate was actually lower, two sets of these were reinstalled. The third was damaged in handling and, therefore, was replaced.

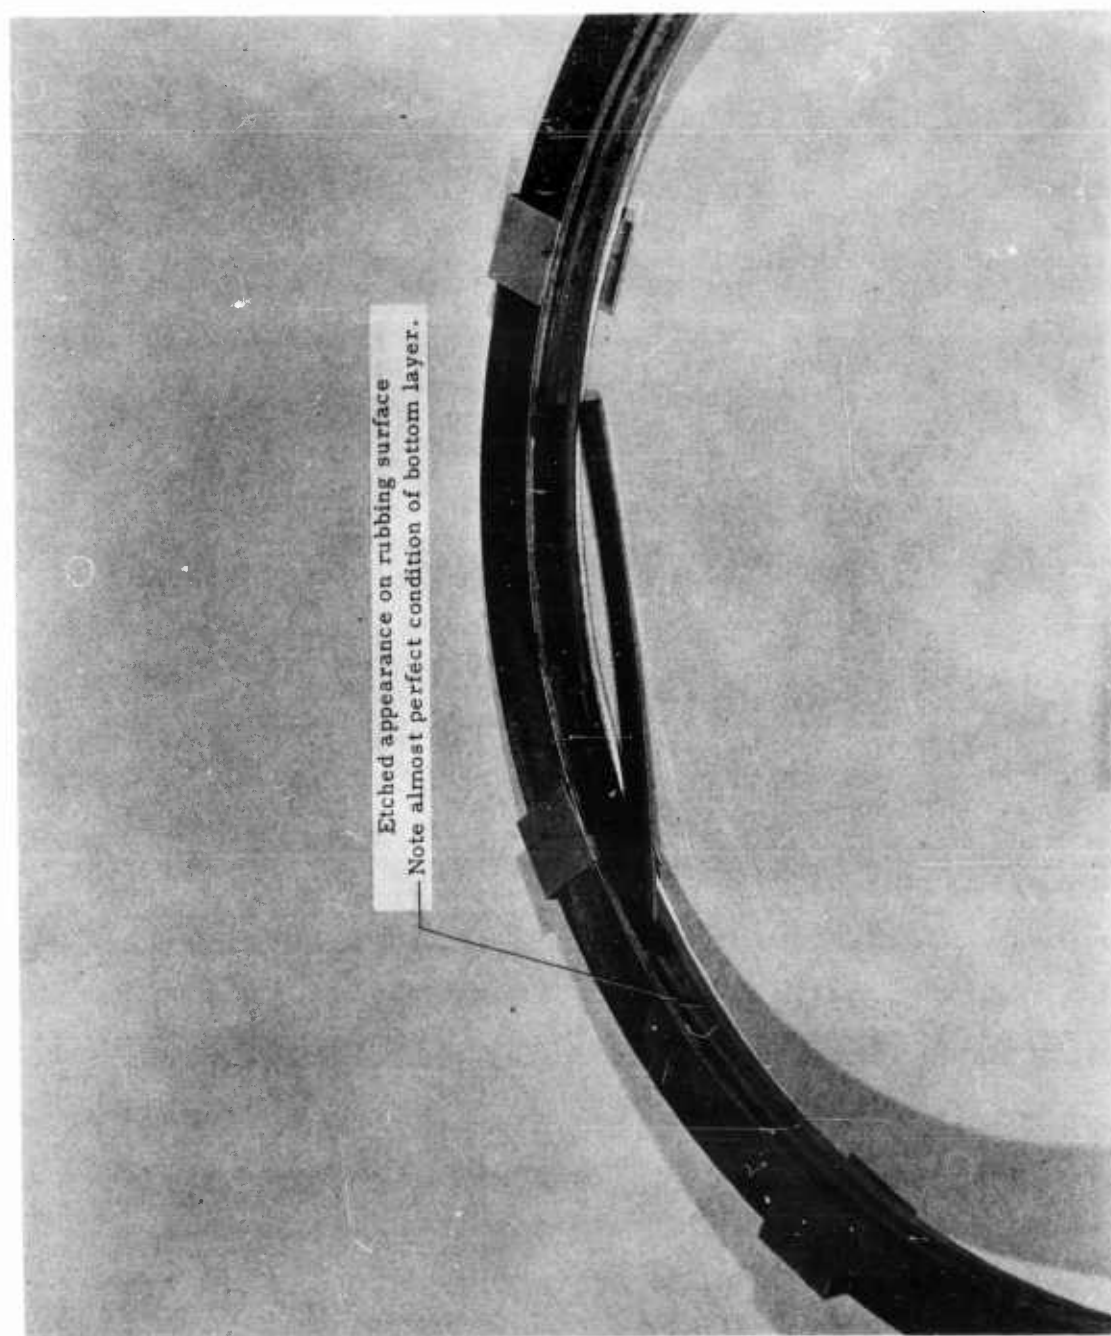
Figure 2.2-2. Etching of Carbon Seals.

- a. The 56 HT, on the upper ring of segments almost exclusively, showed an etched appearance, possibly from the effects of rain water prevalent at that time. The condition is shown in Figure 2.2-2.
- b. The #2490 ring was in excellent condition.
- c. The CDJ-83 segments appeared essentially as before, and leakage rate was essentially identical to the previous values.

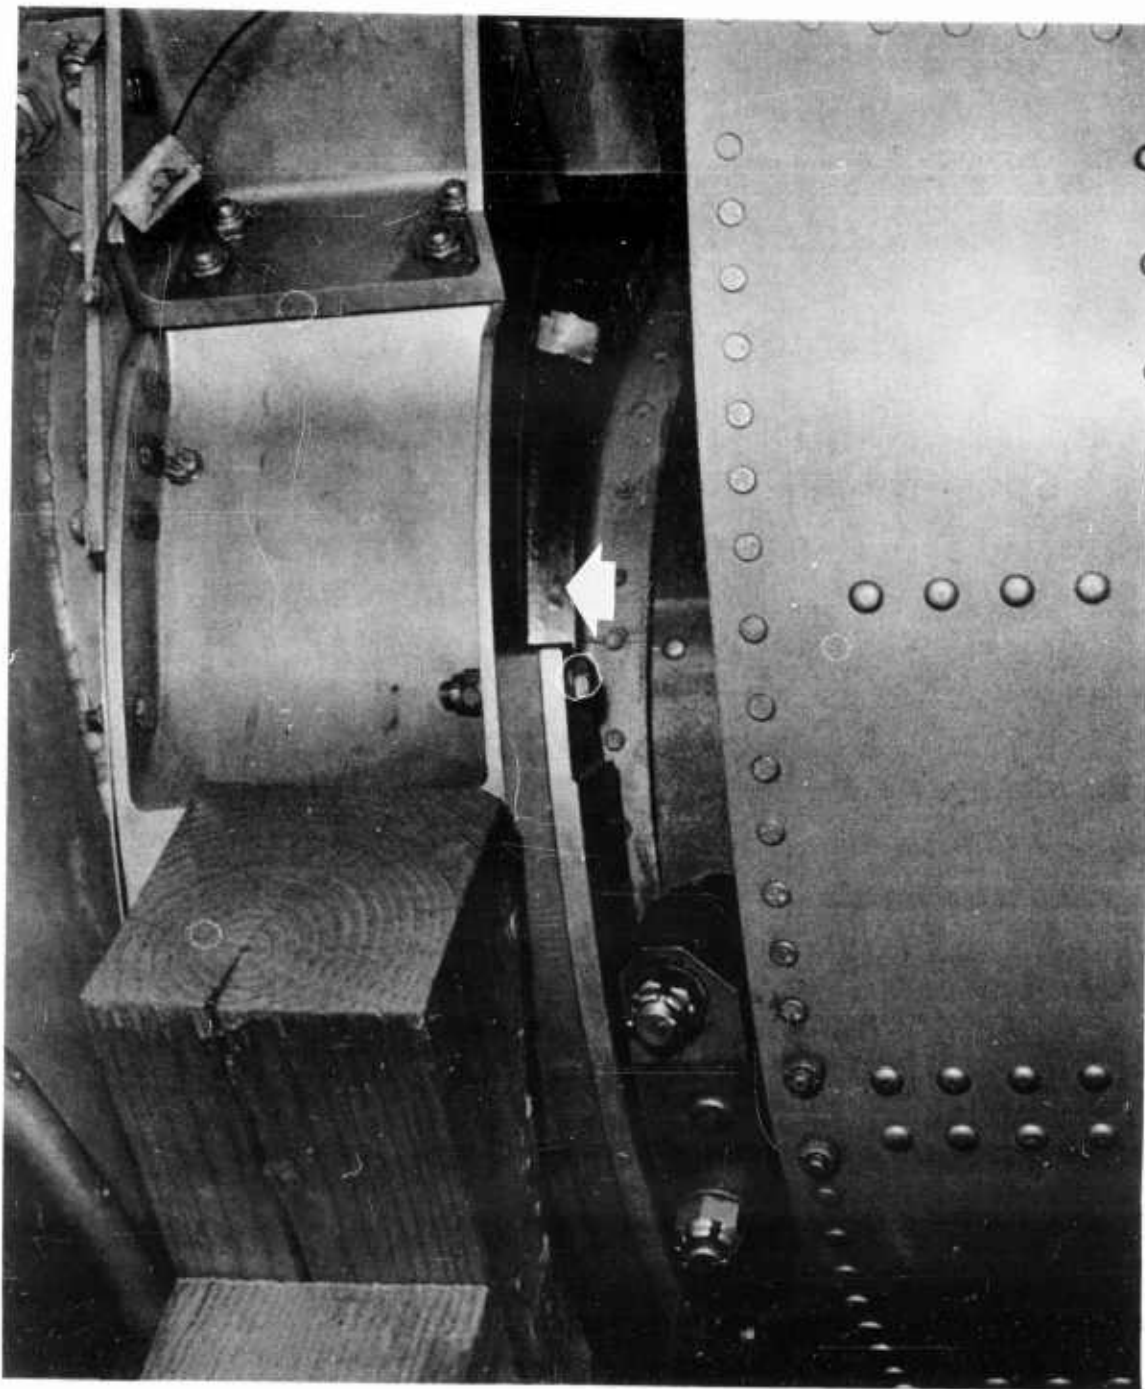
After the feathering balls were put into service on the Hot Cycle whirl test (18 hours of whirl, six months elapsed time within one mile of the Pacific Ocean), some blistering of the chromium plated surface was observed on two

bearings. No corrective action, however, was considered necessary at that time. At the end of a total of thirty-five hours testing (7-1/2 months total elapsed time), it was found that one ball showed no blistering, one had a very small amount in a non-critical region, while the third showed a considerable amount of blistering which approached a critical wear area. The blistering is shown on Figure 3.4-2. It was decided to replace the third ball.

During the time that the above noted balls had been in service, additional investigation was carried on. As a result, it was concluded that a part of the problem was the tendency of some metals, upon exposure to air, to form passive films **which prevent** adhesion of subsequent plating unless completely removed. Aluminum is among the metals requiring special attention in this respect. The passive film was cleaned from the replacement ball by a quick acidic dip and rinsed immediately preceding plating, and an undercoat of 0.002" electroless nickel was applied to exclude moisture at the bimetallic interface. However, gassing occurred during this plating operation which resulted in a blistered nickel deposit. The barrier coat was then stripped and the casting flashed with approximately 0.0001" of copper and again plated with 0.002" of electroless nickel. Some superficial blistering was encountered, but was removed by buffing prior to plating with the final coat of 0.0015" of dense chromium.

Figure 3.4-2. Close-up of Feathering Bearing Ball. Note blistering of chrome plate apparently as result of sub-surface corrosion.

During an additional 25 hours of whirl test and 1-1/2 months elapsed time, the two original balls have indicated no change in surface appearance, and the replacement ball has not blistered.

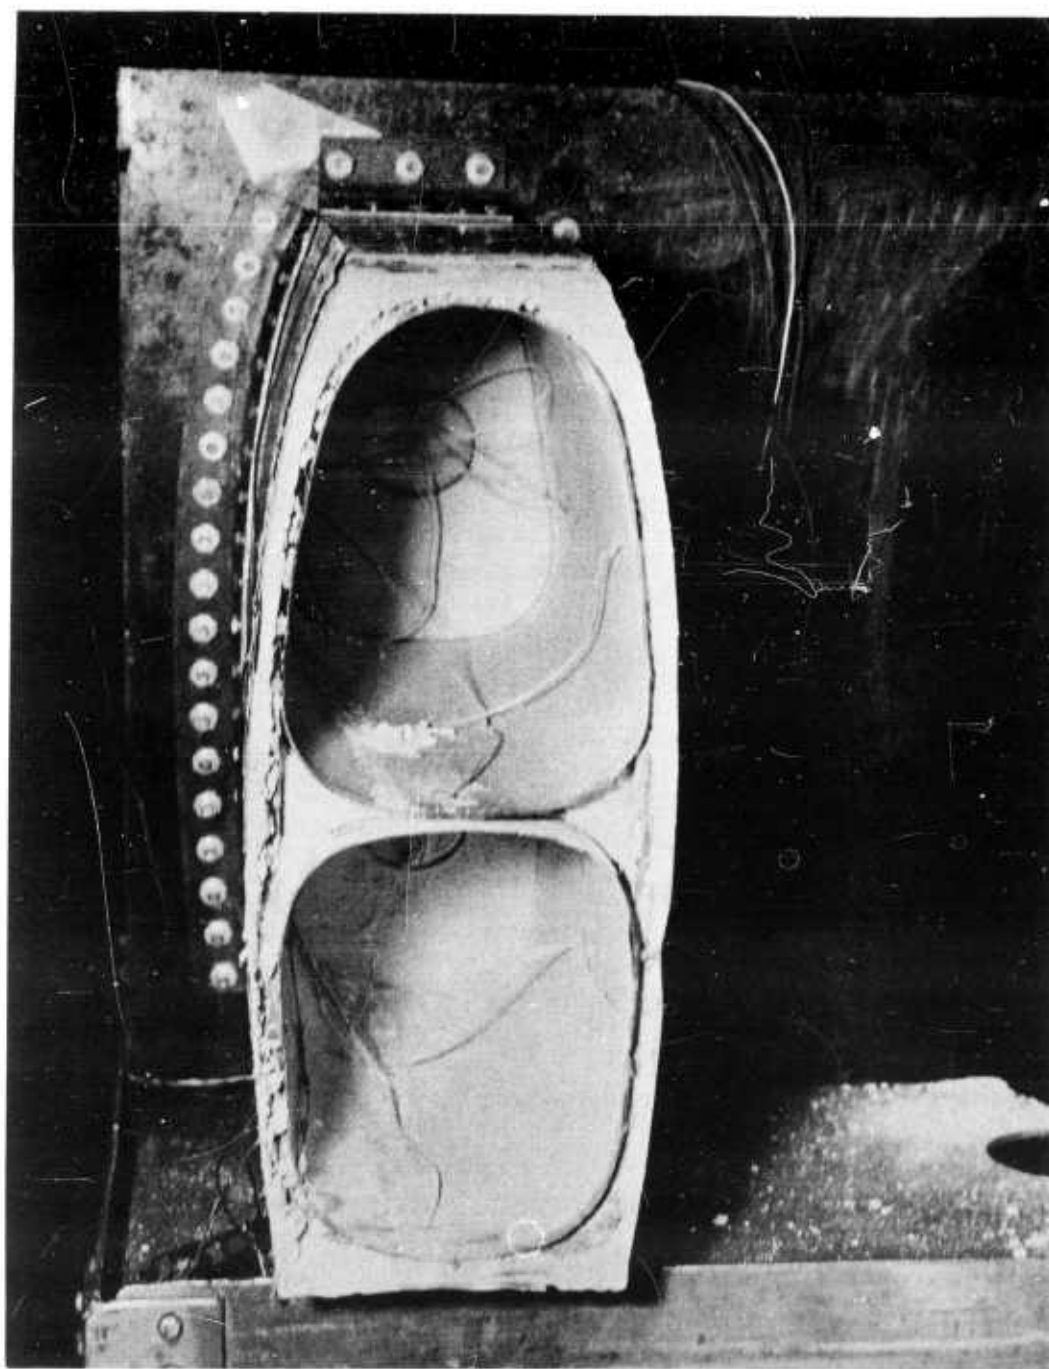
Figure 4.1-2. Results of the Sealant Decomposition Test.  
Note material decomposed around ducts -  
pliable around outer surfaces

Because of the extensive rework involved in disassembling the blades, a repair was attempted by placing a bead of RTV601 Silicone over the existing material. Laboratory tests had indicated that by coating the existing silicone material with Dow Corning A 4094 Primer a satisfactorily cured seal could be produced. A pressure gun with a 1/8" O. D. tube attached was used through a rivet hole to lay the bead. This was by nature a blind operation and in several areas RTV601 Silicone was forced into the duct area, similar to that shown on the test specimen of Figure 4.1-2. This in turn created a question of the stability of RTV601 at 1100 to 1150°F.

Preliminary laboratory tests gave evidence of burning of the RTV601 at 850 to 900°F. Tests were run at Truesdale Laboratories of Los Angeles which established the autoignition temperature of RTV601 Silicone gases to be in the range of 850° to 900°F, confirming HTC-AD tests indicating ignition at 900°F. In addition, actual blade specimen tests with operational temperatures were conducted by HTC-AD to determine effects under simulated operating conditions. These are reported in Reference 1.

The completely sealed blades, which had a pressure loss of less than 4 CFM per blade at 23 psig, were installed on the whirl tower. Based on recommendations of Dow Corning and the results of the tests at Truesdale, the initial whirling was done at 800°F maximum duct temperature for 7 hours. When no difficulty was experienced, the duct temperature was raised gradually to an eventual 1188°F without difficulty being experienced with the RTV601 sealant. The blades were pressure tested several times during the whirl tests and, without reworking the RTV601 sealant areas, produced leakage comparable to that obtained when the blades were originally installed. The blade subsequently completed 60 hours of whirl testing without further problems involving the RTV601 Sealant.

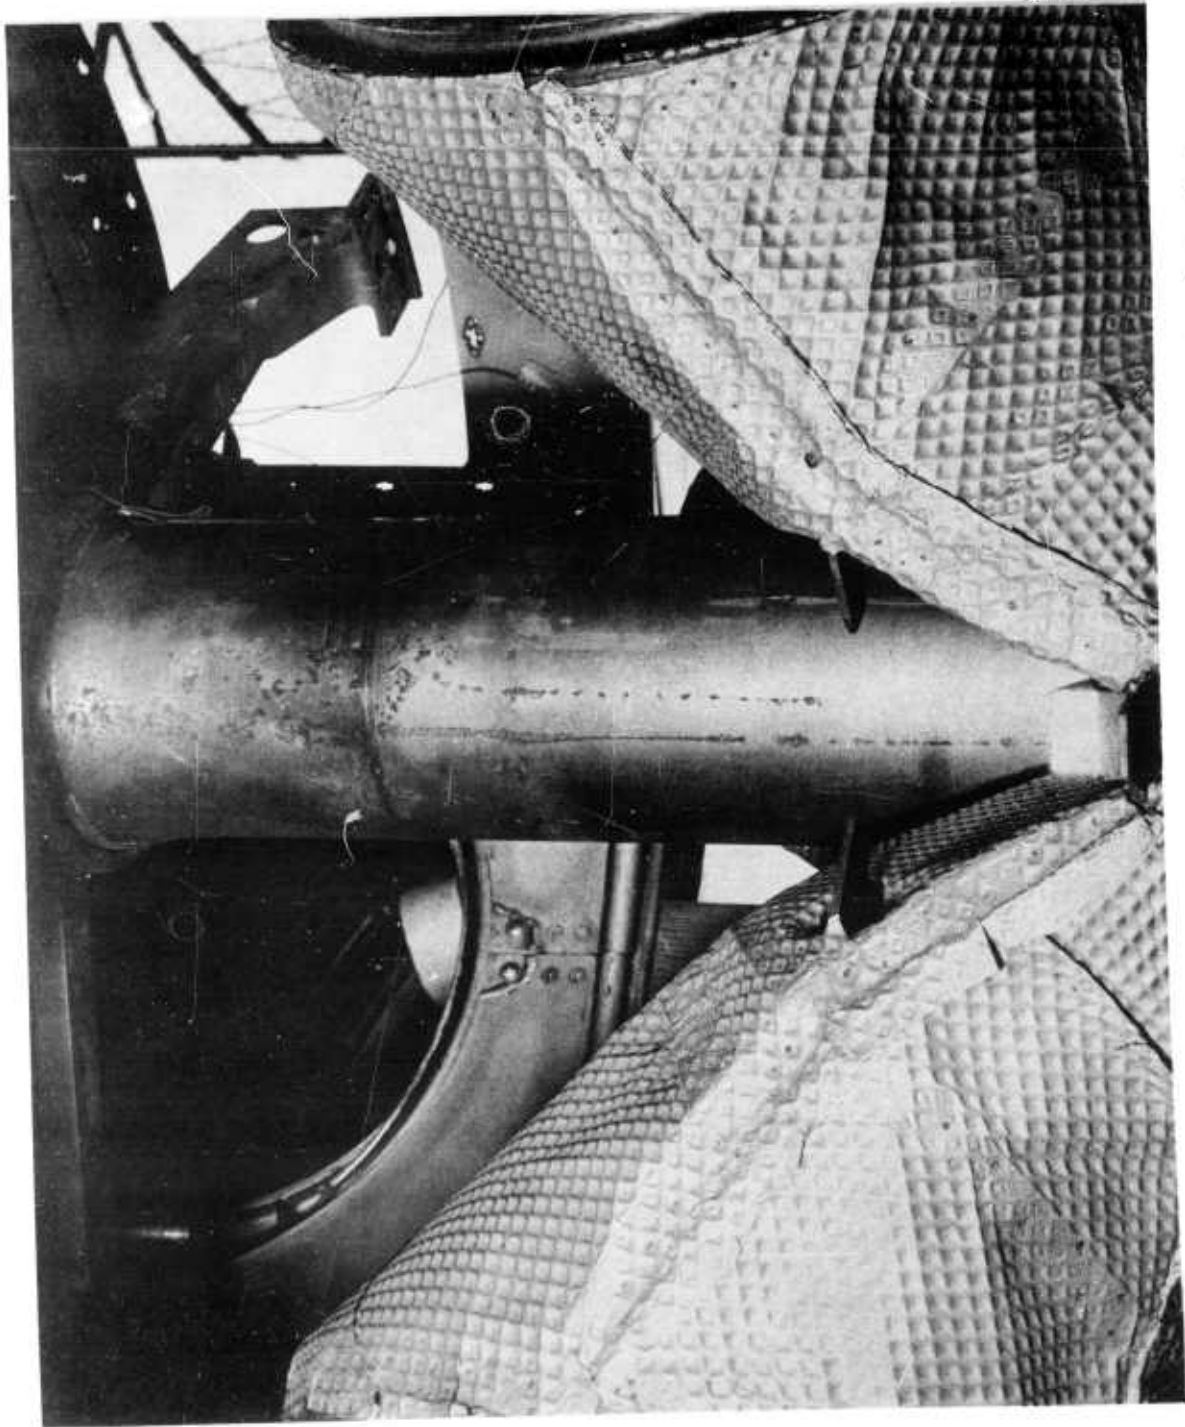
Testing of specimens in salt spray atmosphere showed that the gold paint reduced the corrosion resistance of the nickel surface. However, since the tests showed the reduction in corrosion resistance was relatively small, and because of the desire for a surface of maximum reflectivity to the heat radiated from the ducts, the gold paint was applied to the mast and spoke piece.

The corrosive action of the atmosphere in the area of the shaft, however, was apparently more severe than was expected, because extensive corrosion and deep pitting occurred, as shown in Figure 4.2-1. In contrast it is noteworthy that the spoke piece was free of corrosion. Temperatures recorded for the various portions of the shaft, on the other hand, were considerably lower than those anticipated. For these reasons the gold paint was removed after 18 hours of whirl test (6 months elapsed time) and the surfaces covered with an aluminum filled silicone base paint. This paint has a lower reflectivity but a substantially improved corrosion resistance. It performed quite satisfactorily in both corrosion protection and heat reflection functions during 42 hours (4 months elapsed time) of whirl testing.

Figure 4.2-1. Close-up of Hub Shaft and Support Spoke, Gold-Painted for Heat Reflectivity. Note corrosion on shaft, and absence of same on spoke.
